# CASE STUDY No 3

## Casing Inspection

The use of the Cereus Nusonix Ultrasonic logging tool to deliver high accuracy wear measurements in 9<sup>5</sup>/<sub>8</sub>" casing for slot recovery applications.

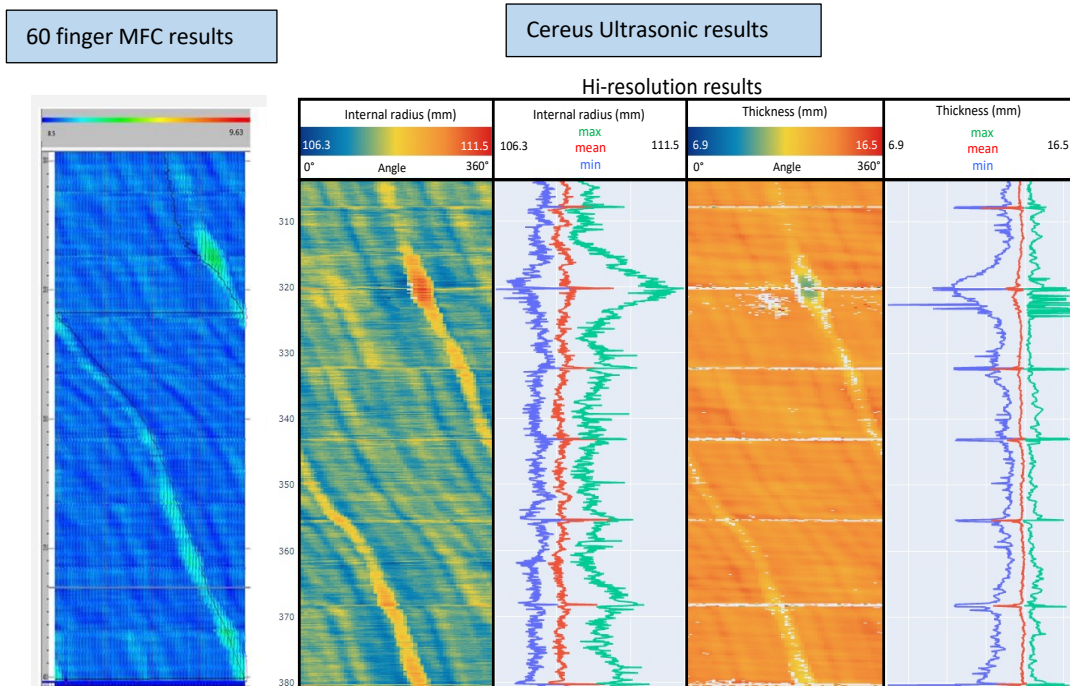
In comparison with the MFC, the Ultrasonic tool provided a significant improvement in the resolution of the internal radius measurement. The scale on the MFC plot (bright blue) has a full range of 1.13" (28.7mm) compared to the equivalent ultrasonic plot having a full range on the colour scale of only 0.2" (5.2mm). The wall thickness measurement shows excellent consistency over the length of the casing except at the point of erosional wear due to the drilling operations.

Both the MFC and the Ultrasonic tool clearly identified internal casing wear due to drilling operations, with the ultrasonic providing an absolute measure of the casing wall thickness.

Using the MFC internal radius results alone in the API approved casing wear calculation, the results delivered a pessimistic casing wear which exceeded the client allowable threshold.

The absolute measurement of the wall thickness provided by the Nusonix Ultrasonic tool provided an accurate direct measure of wear which was within the client's prescribed cut-off.

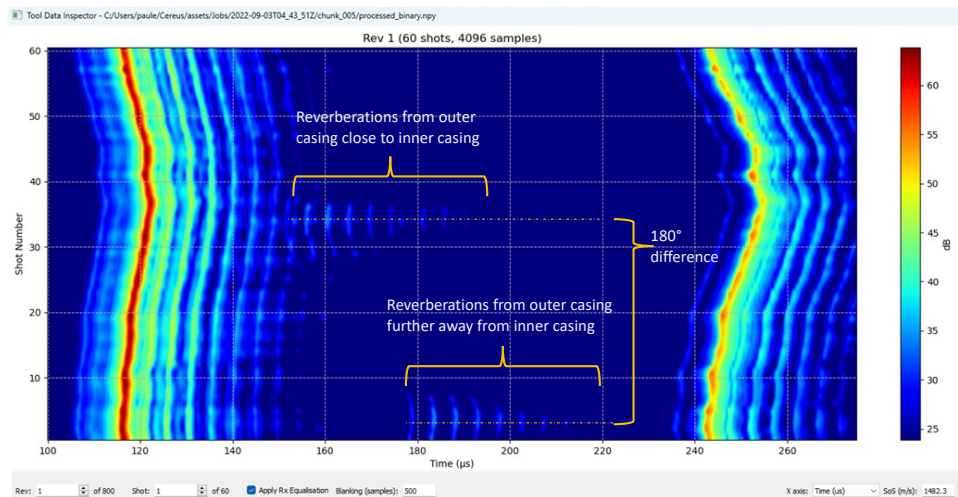
### Multi-casing detection

In addition to the high precision direct measurement of the wall thickness allowing the accurate determination of metal loss, the Ultrasonic tool also detected the subsequent casing from within the 9<sup>5</sup>/<sub>8</sub>" casing. At a deviation of over 60°, the casings were eccentric to one another, given this, the Ultrasonic tool has limited radial recovery of the acoustic pulse. In this scenario of extreme eccentricity, enough information is provided to map the subsequent casing position.

Observation of 2<sup>nd</sup> casing.

Single revolution of the transducer

60 shots = 360°

In addition to the internal radius and wall thickness measurement, the Ultrasonic tool provided secondary information on the relative position of the 13<sup>3</sup>/<sub>8</sub>" casing.
